**ORDER
ISSUED UNDER THE
WATER POLLUTION CONTROL ACT
WEST VIRGINIA CODE, CHAPTER 22, ARTICLE 11**

TO: Benedum Airport Authority
Attn: Richard Rock
2000 Aviation Way
Bridgeport, WV 26330

DATE: March 14, 2022

ORDER NO.: 10033

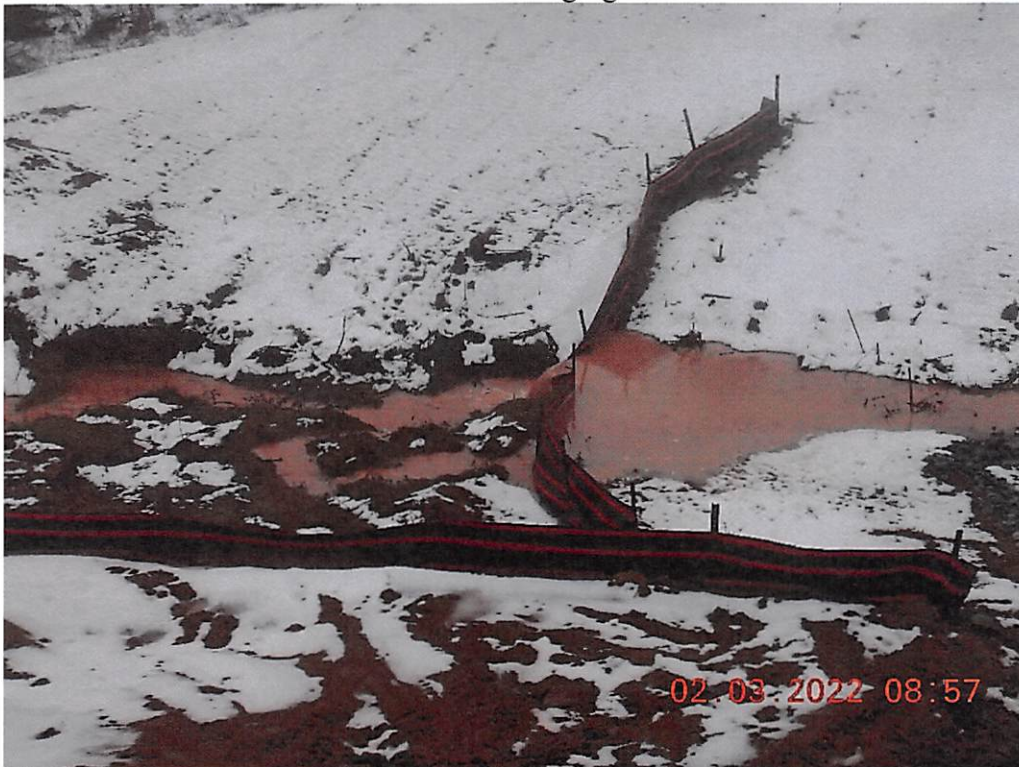
- a. Appendix B.I.1. – Benedum Airport Authority failed to properly operate and maintain all activities and installed BMPs. There were several areas on the project, especially around Pad 2, where the silt fence was undercut, allowing sediment laden water to discharge off-site. There was also one section of the clean water diversion (Diversion Ditch 2) that was discharging sediment laden water into Sediment Basin 3 due to a maintenance issue.

Photo shows a concentrated flow overtopping silt fence near the outlet for Pad 2. This is where the sediment laden water for the rock core drain flows.

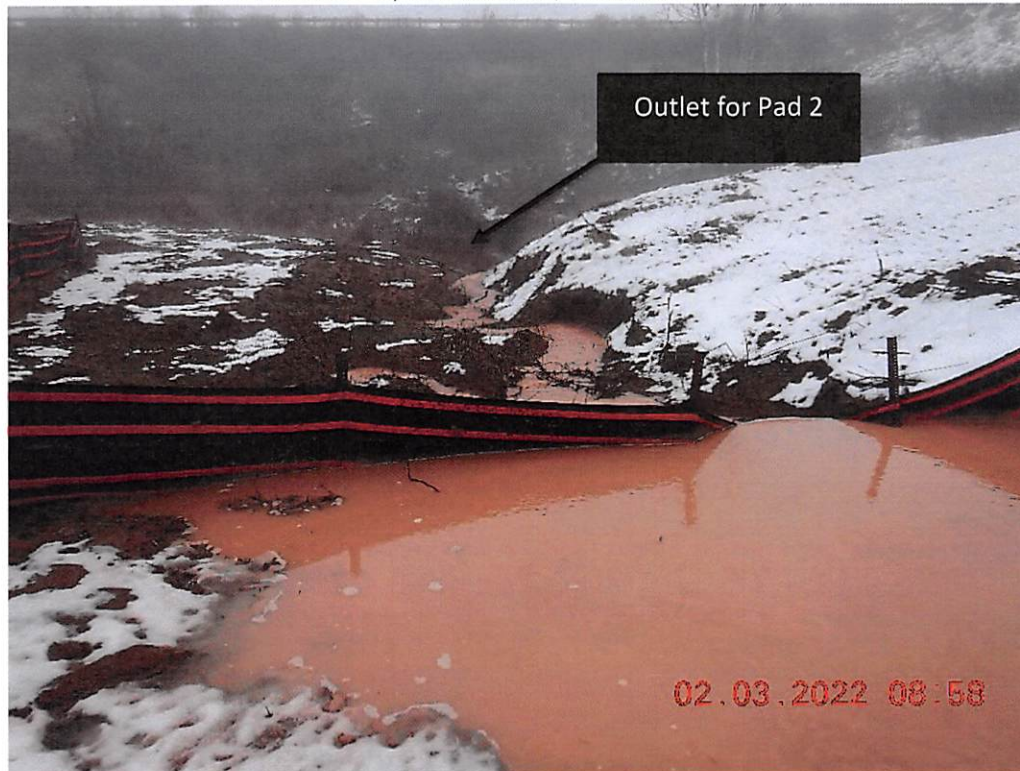
Photo shows the sediment laden water flowing into the outlet for pad 2 and off-site.

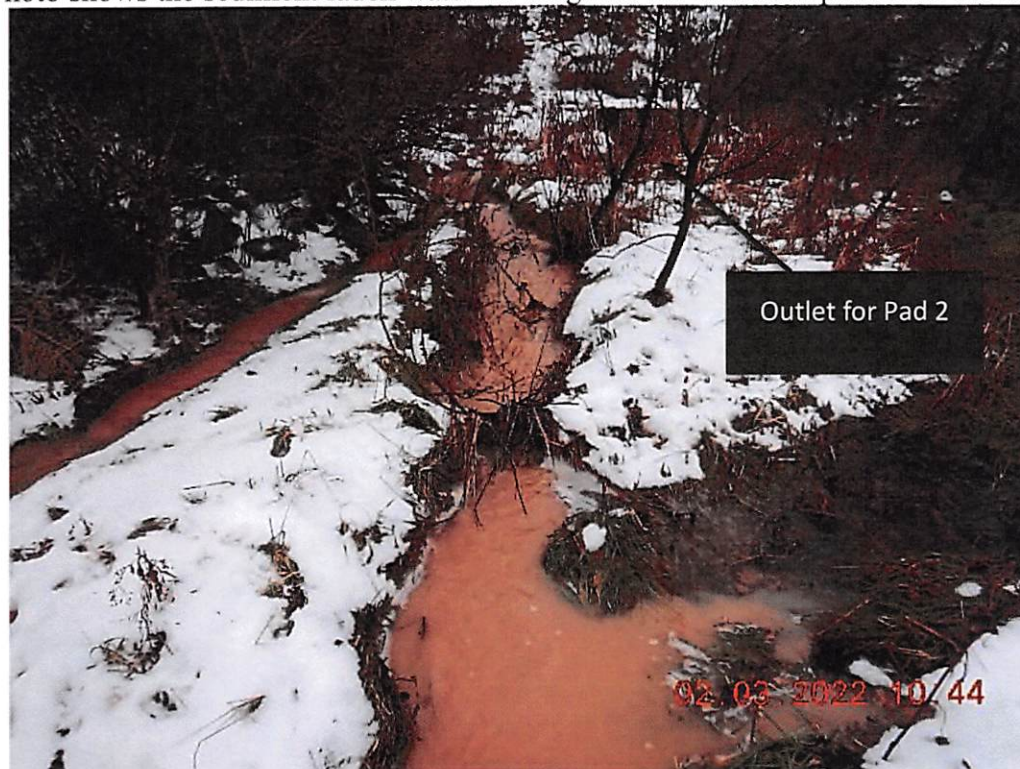
- g. 47CSR2 Section 3.2.a.- Benedum Airport Authority caused conditions not allowable in waters of the State by creating distinctly visible settleable solids in the Unnamed Tributary (UNT) of Peddler Run and the UNT of Ann Run.

Photo shows CNA in UNT of Peddler Run.

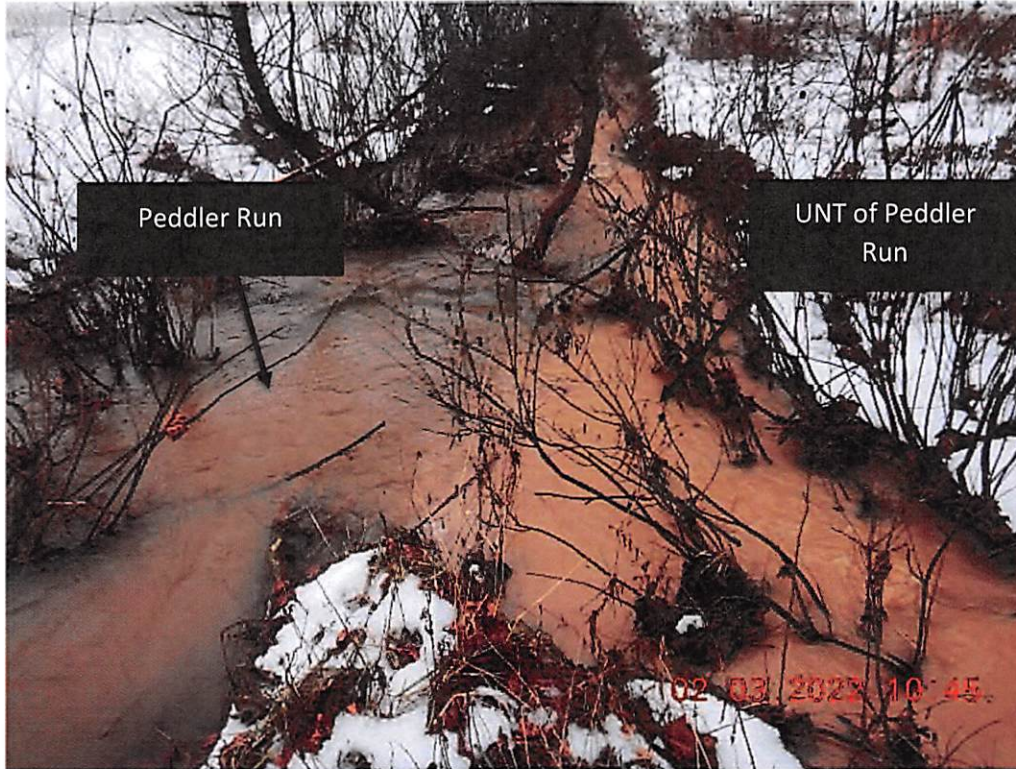
Photo shows the confluence of UNT with Peddler Run.

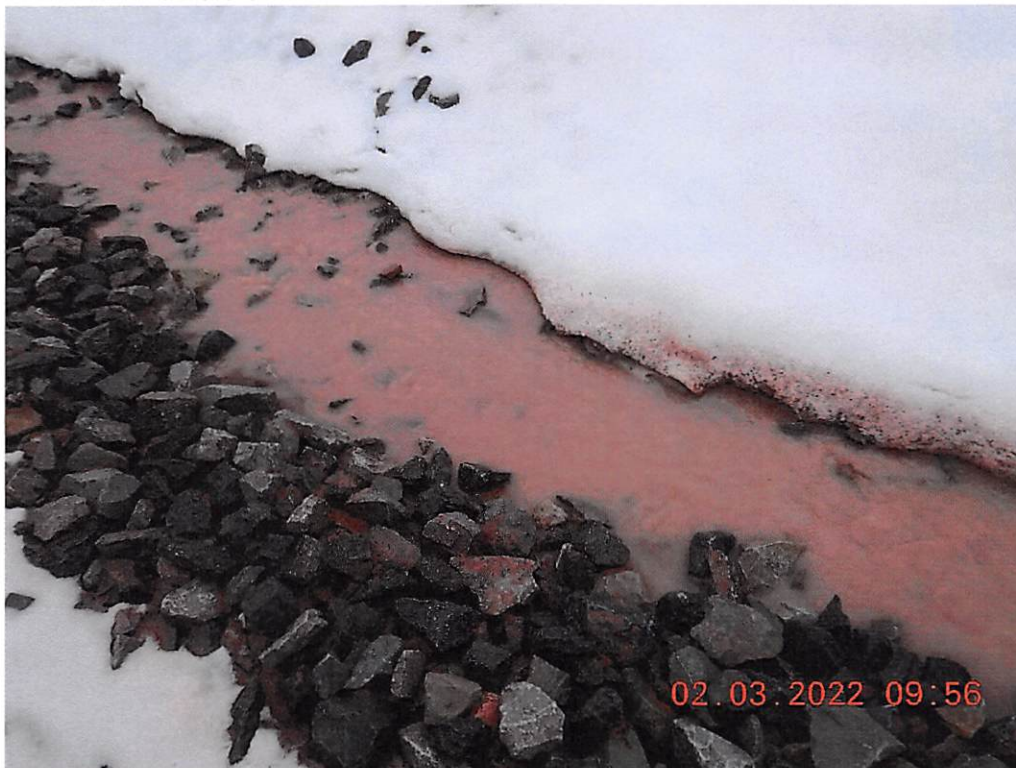
Photo shows sediment laden water running down a diversion ditch leading to the outlet for Pad 1.

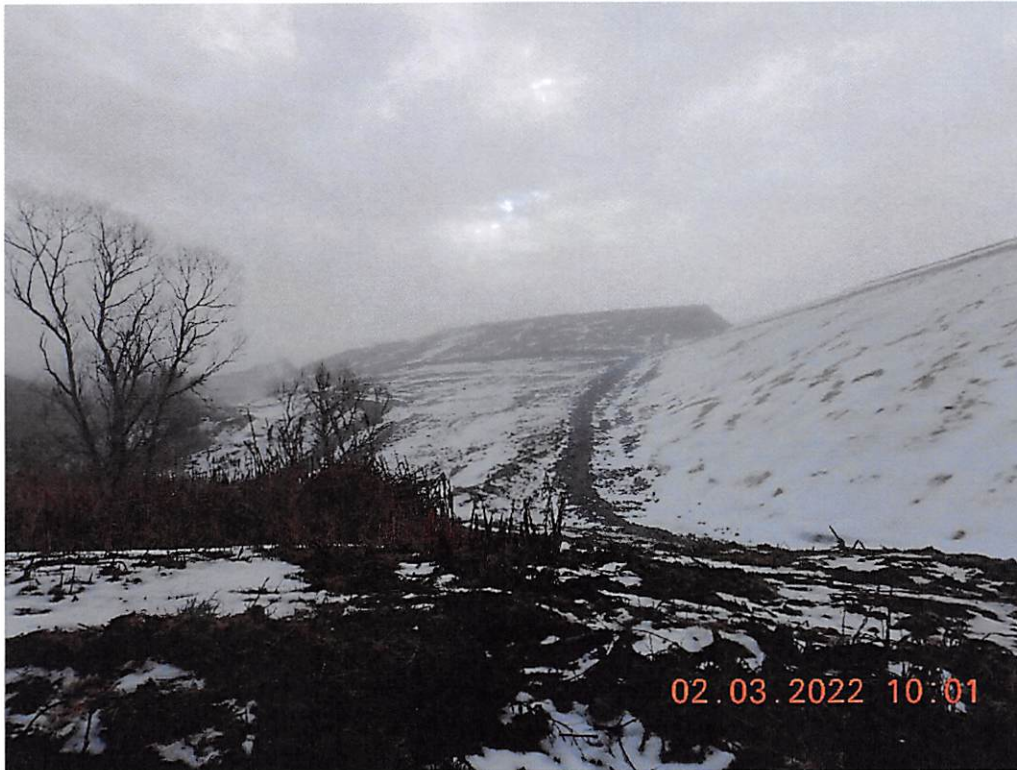
Photo shows the diversion ditches running down to the outlet for pad 1 without any BMPs in place.

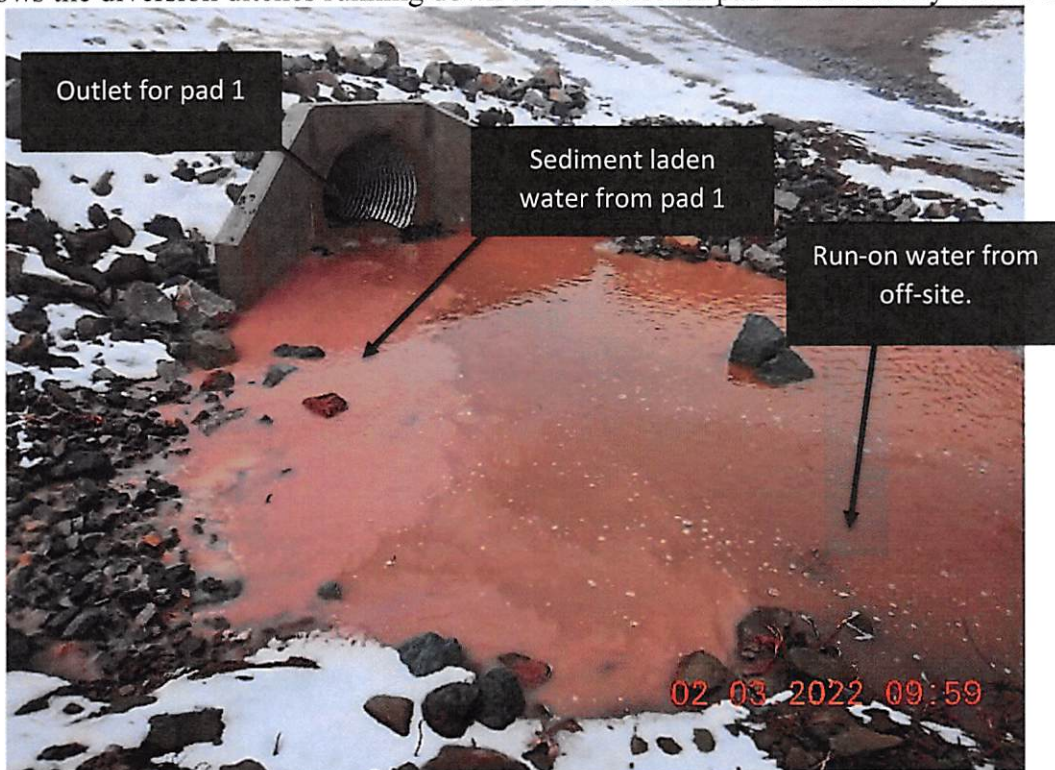
Photo shows sediment laden water from pad 1 being discharged into an outlet that leads offsite.

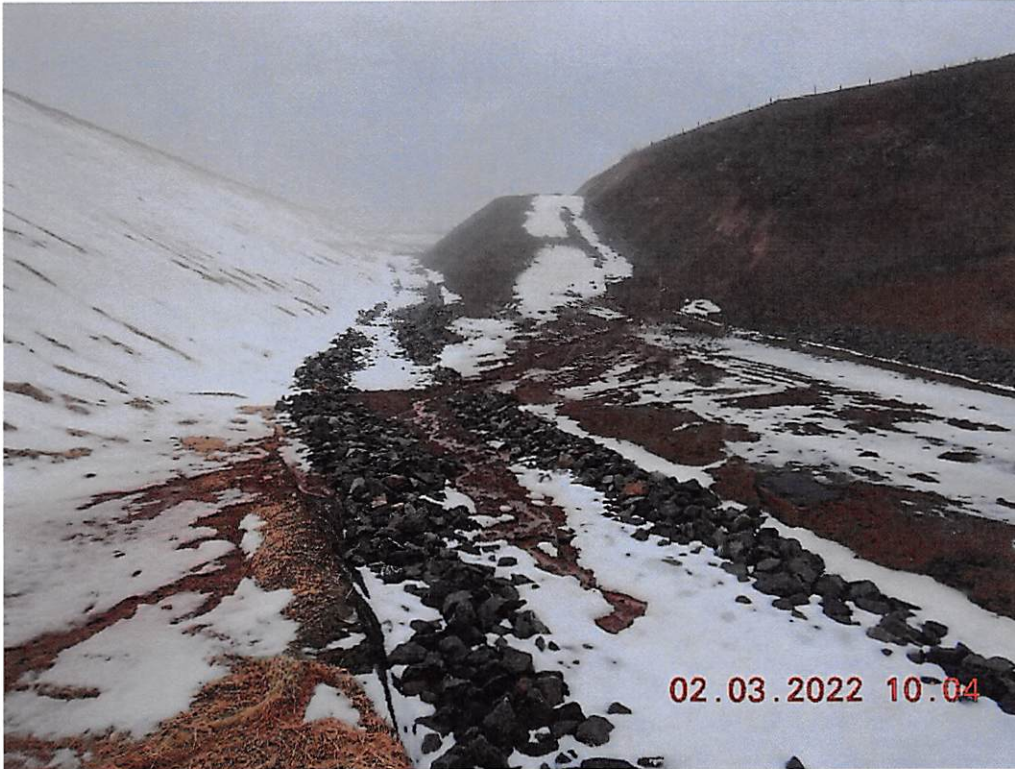
Photo shows sediment laden water running into a diversion ditch that leads to the outlet for pad 1. There is no BMP for the stormwater.

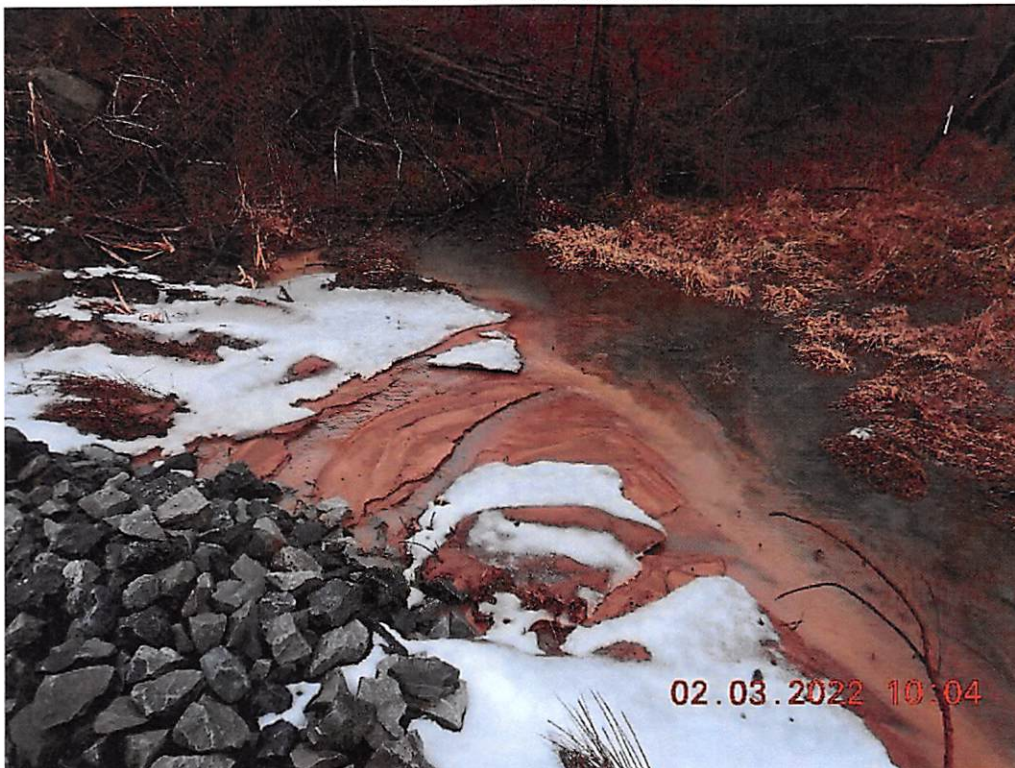
Photo shows sediment laden water from the ditch in the previous picture discharging into a small spring that leads to the outlet.

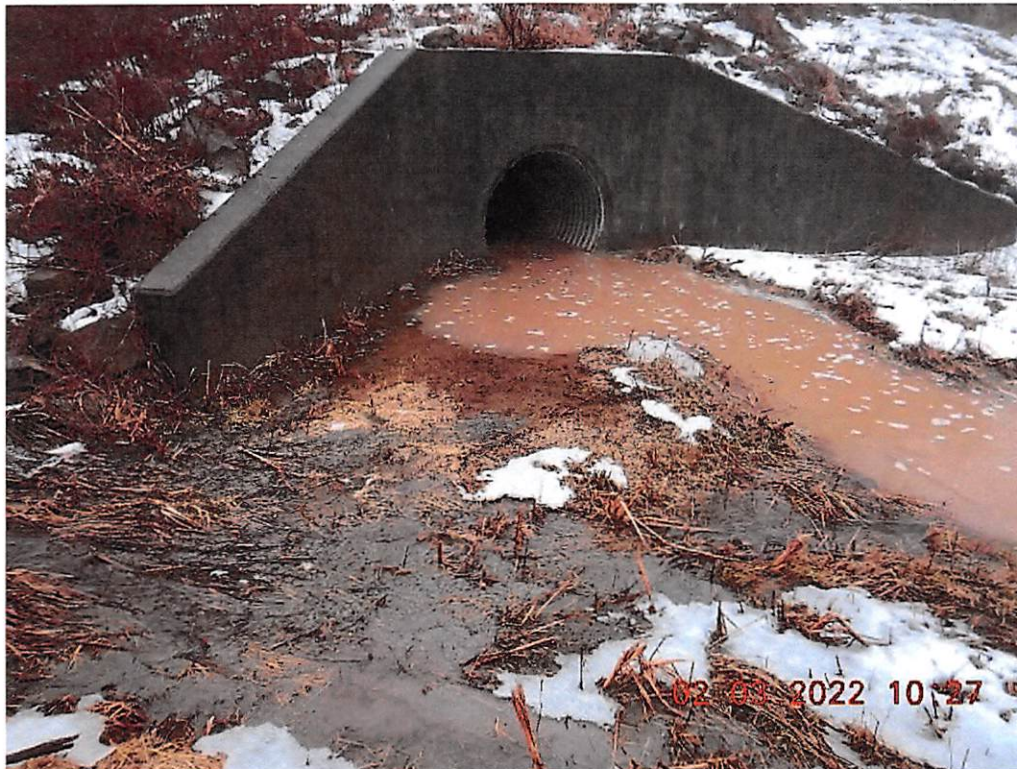
Photo shows CNA in the UNT of Ann Run.

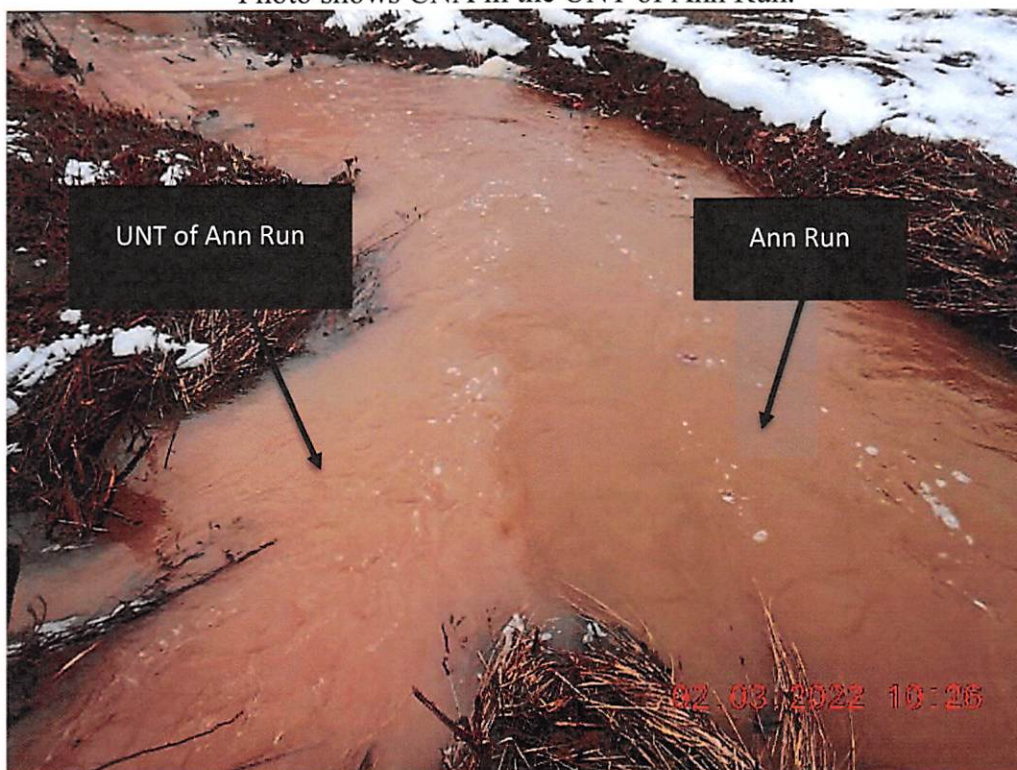
Photo shows confluence of UNT with Ann Run.

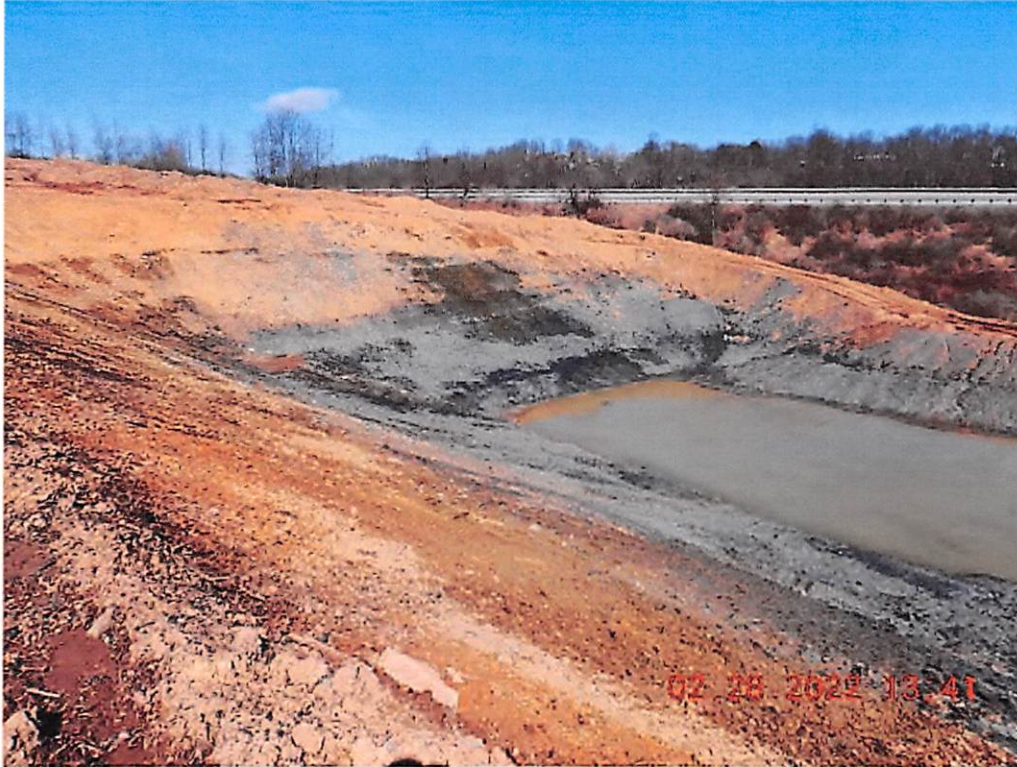
- b. Section II.H.3.b.11.- Benedum Airport Authority failed to properly operate the sediment basins. Sediment Basin 2 and Sediment Basin 3 were not holding water due to a leaking riser. Water was actively discharging underneath the pipe and out of the basin.

Photo shows Sediment Basin 2, which does not hold water due to a leaking riser.

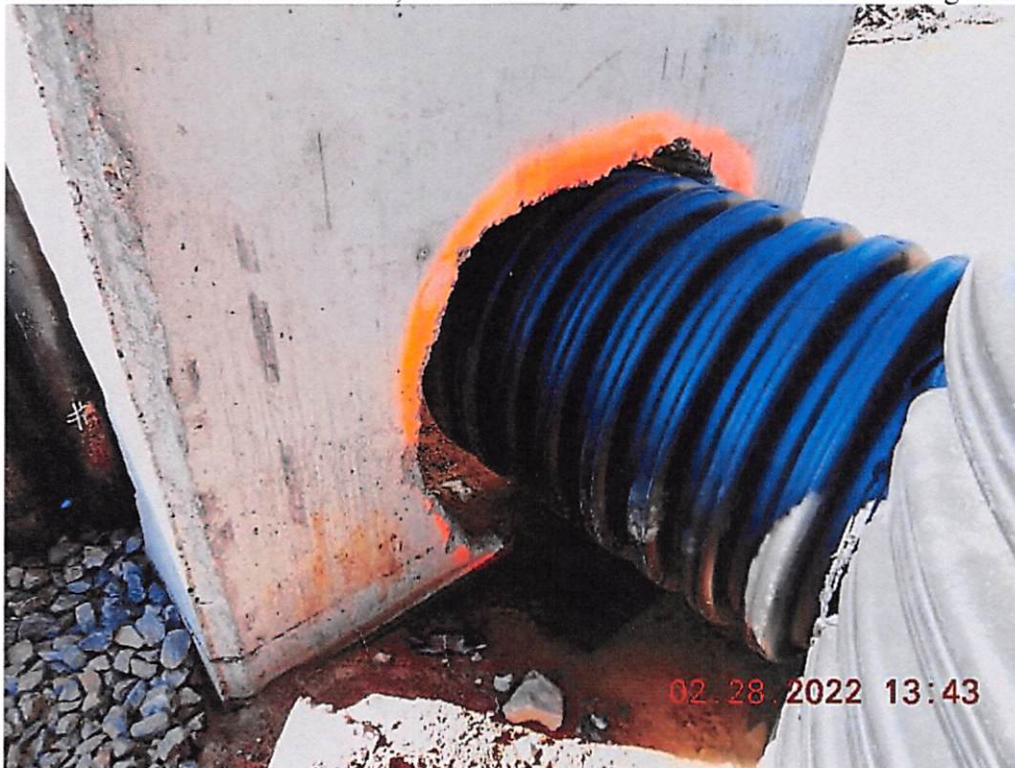
Photo shows the riser for Sediment Basin 2. The riser has not been sealed since the previous inspection, and the basin does not hold water.

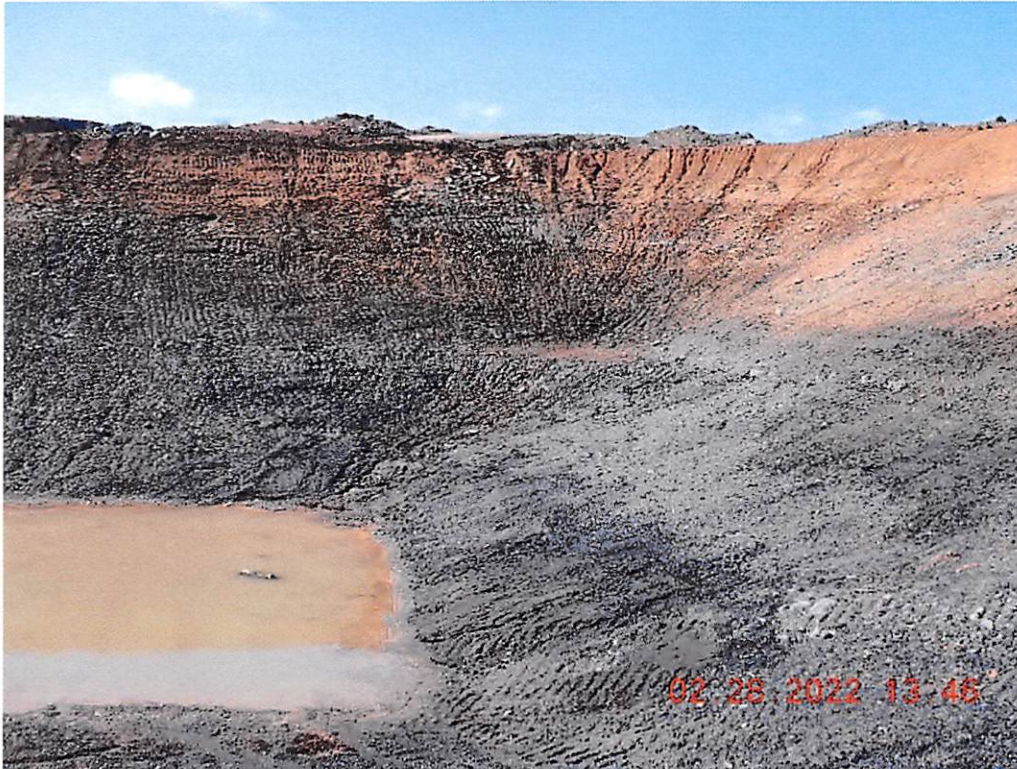
- g. Section II.H.3.b.13.- Benedum Airport Authority failed to provide inlet and outlet protection for sediment control structures. There were also no dump rock gutters installed to Sediment Basin 2, causing fill slope erosion and an unstable inlet for Sediment Basin 2 at a volunteer inlet to the basin.

Photo shows an unstabilized inlet for Sediment Basin 2. According to the SWPPP, there should be a dump rock gutter installed to protect the fill slope and stabilize the inlet.

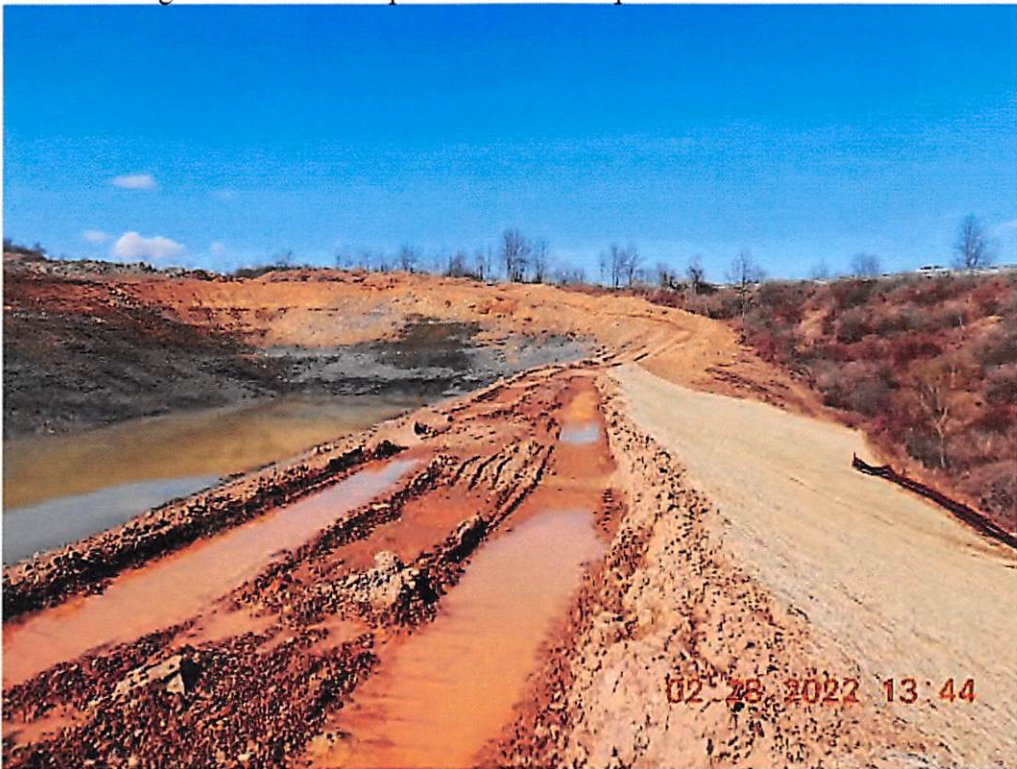
Photo shows an unstabilized road that runs around Sediment Basin 2. This road conveys water down the hill and around the sediment basin.

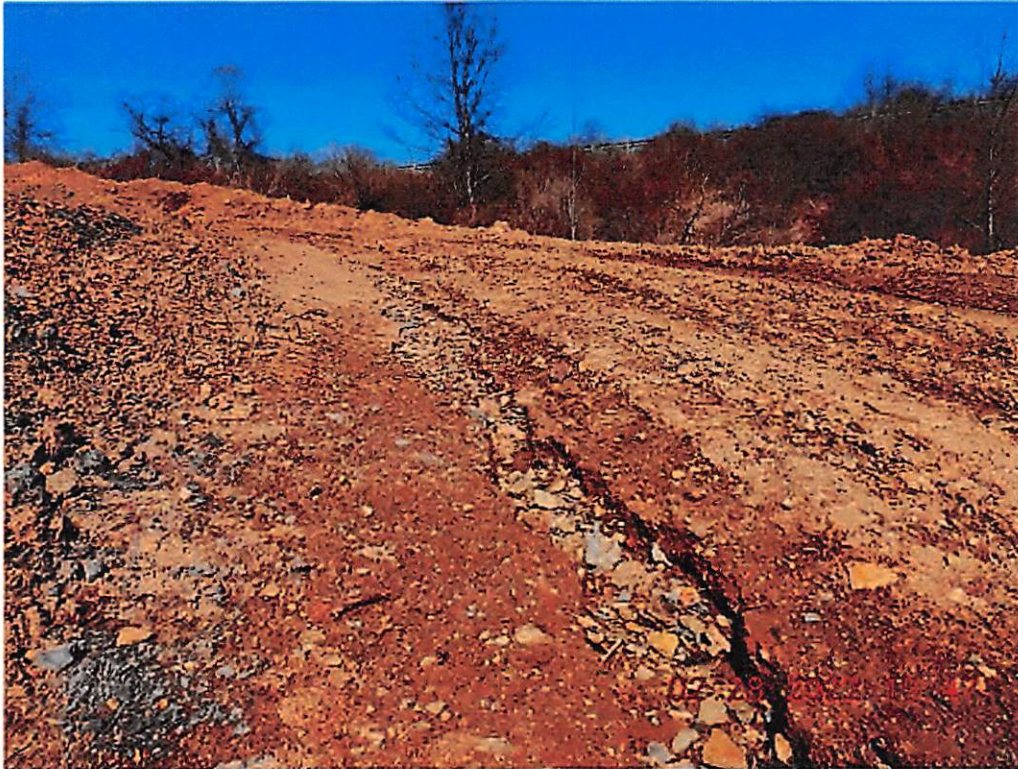
Photo shows the road from the previous pictures with erosion rills.

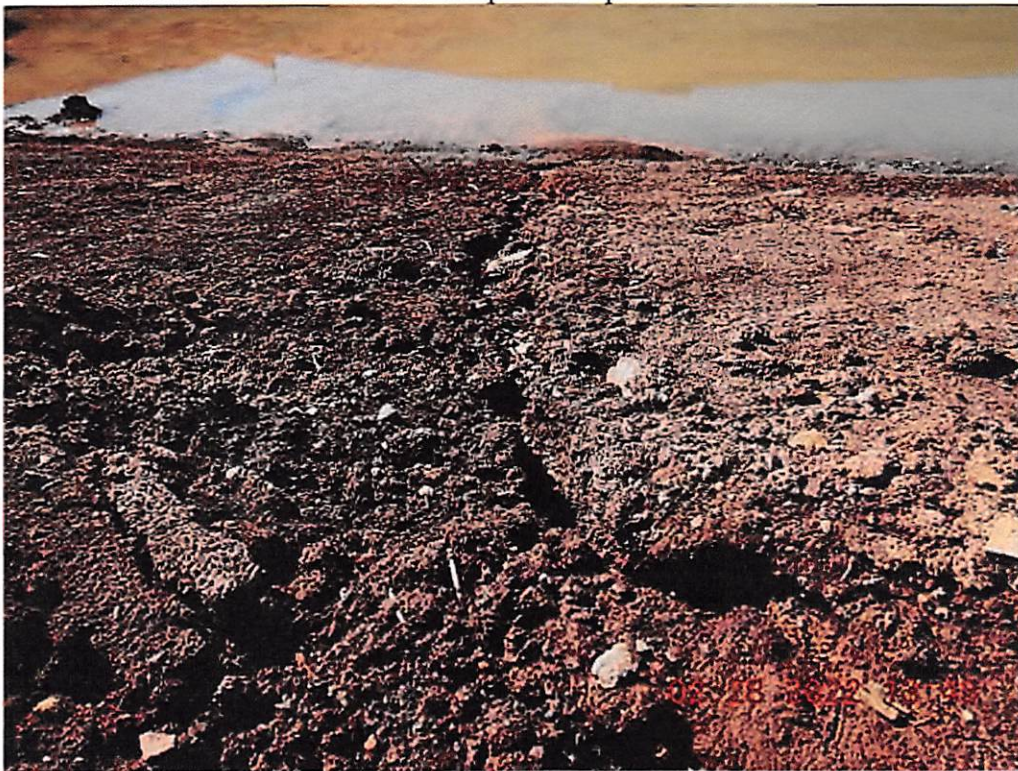
Photo shows erosion rill on the bank of Sediment Basin 2 at another unstabilized inlet.

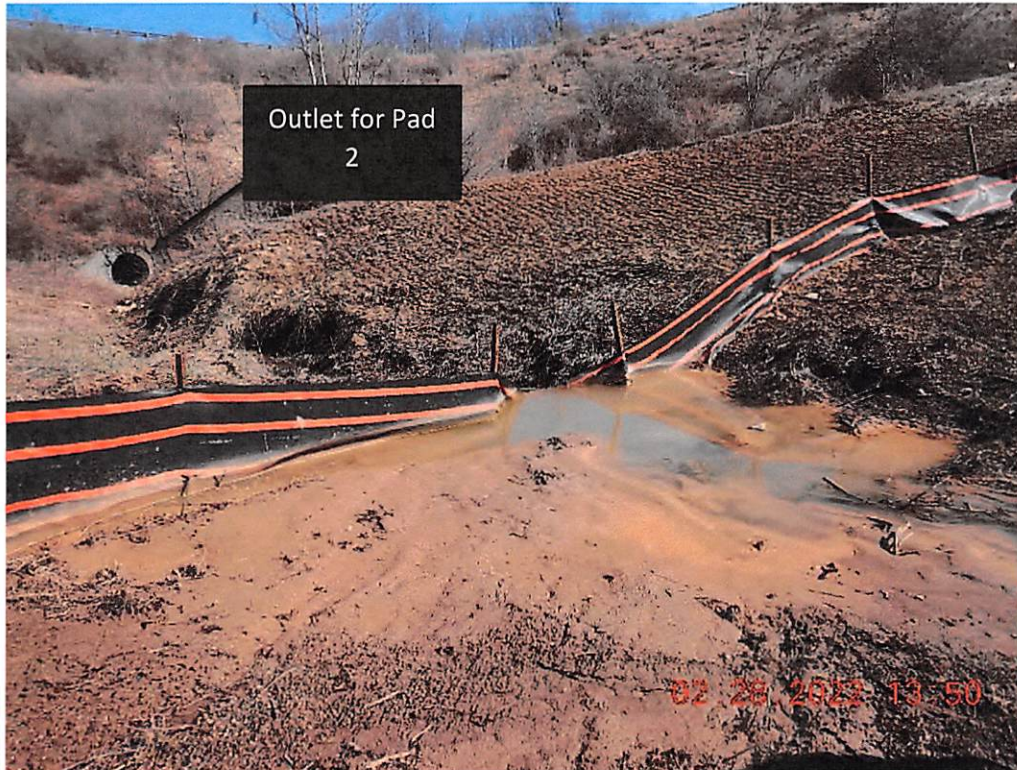
Photo shows a concentrated flow overtopping a silt fence near the outlet for pad 2. The fence is also overwhelmed with sediment from the previous rain.

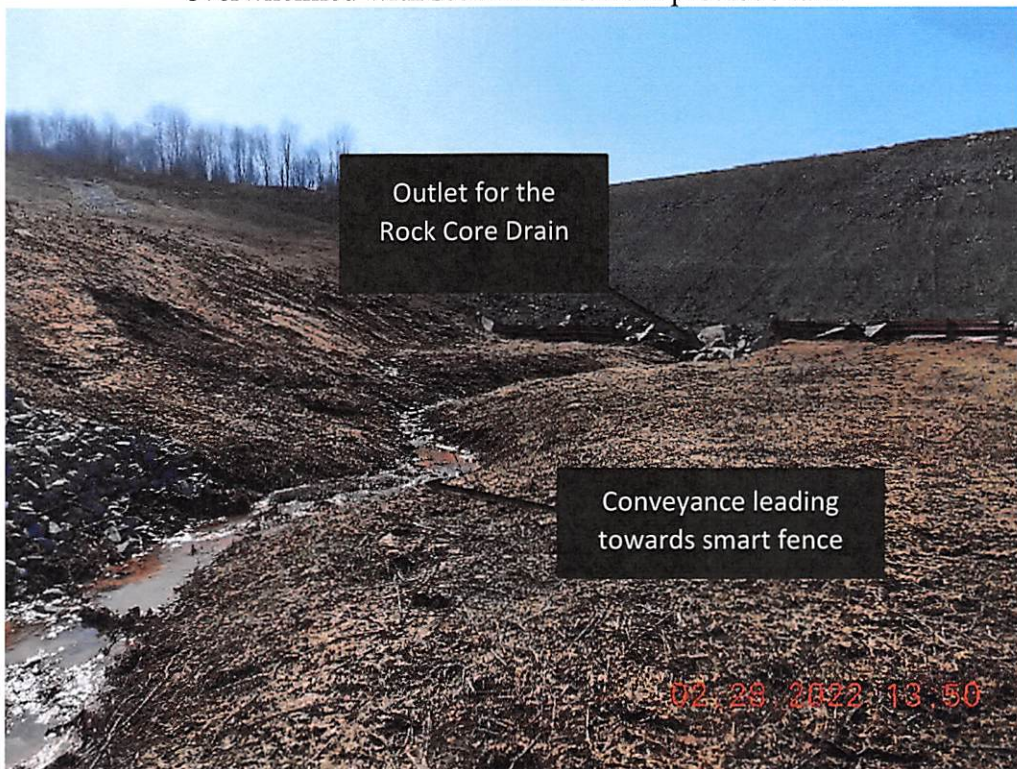
Photo shows the outlet of the rock core drain for Pad 2. This is the conveyance that leads directly to the silt fence from the previous photo.

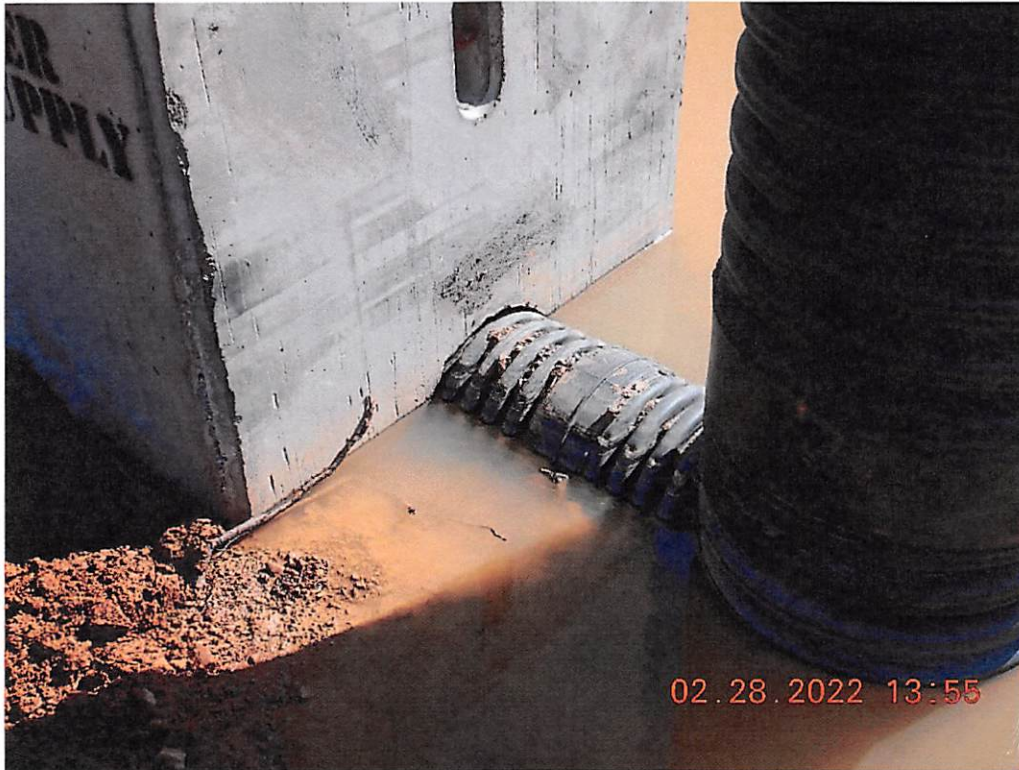
Photo shows the leaking riser for Sediment Basin 3, which is also not holding water.

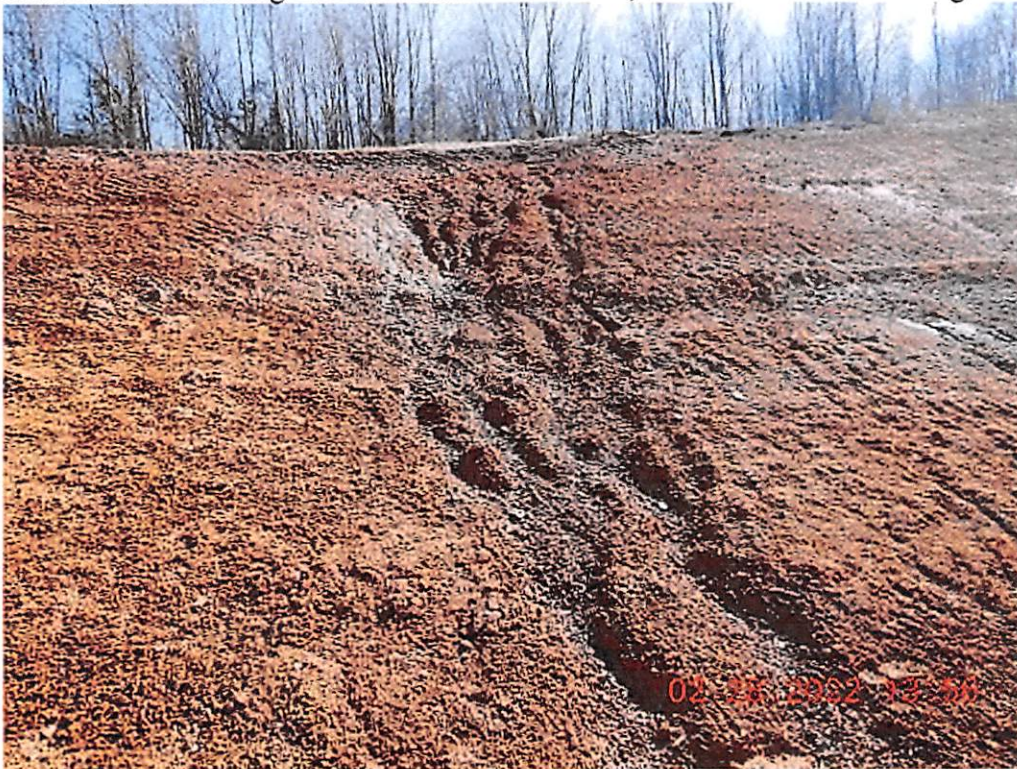
Photo shows an unstabilized inlet for Sediment Basin 3 coming off the clean water diversion (diversion ditch 2).

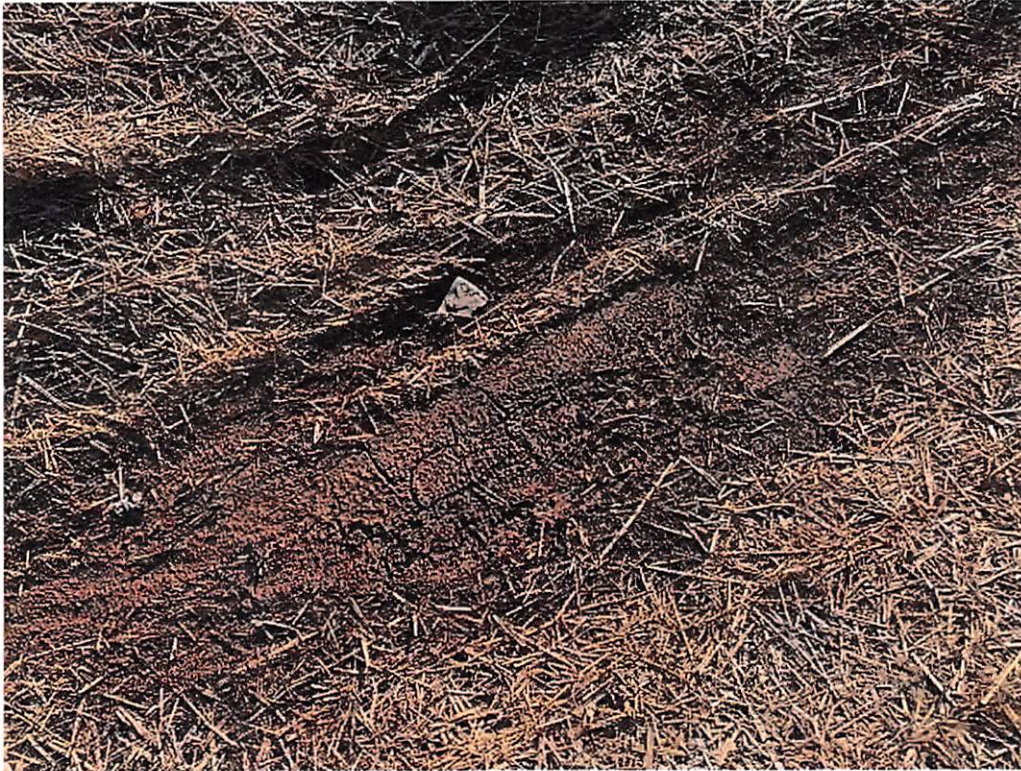
- e. Section II.H.3.b.9. - Benedum Airport Authority failed to stabilize clean water diversions prior to becoming functional. The clean water diversion around Pad 2 was not properly stabilized, causing sediment laden water to bypass all the controls and discharge off-site.

Photo shows the clean water diversion (diversion ditch 2) that is not properly stabilized.

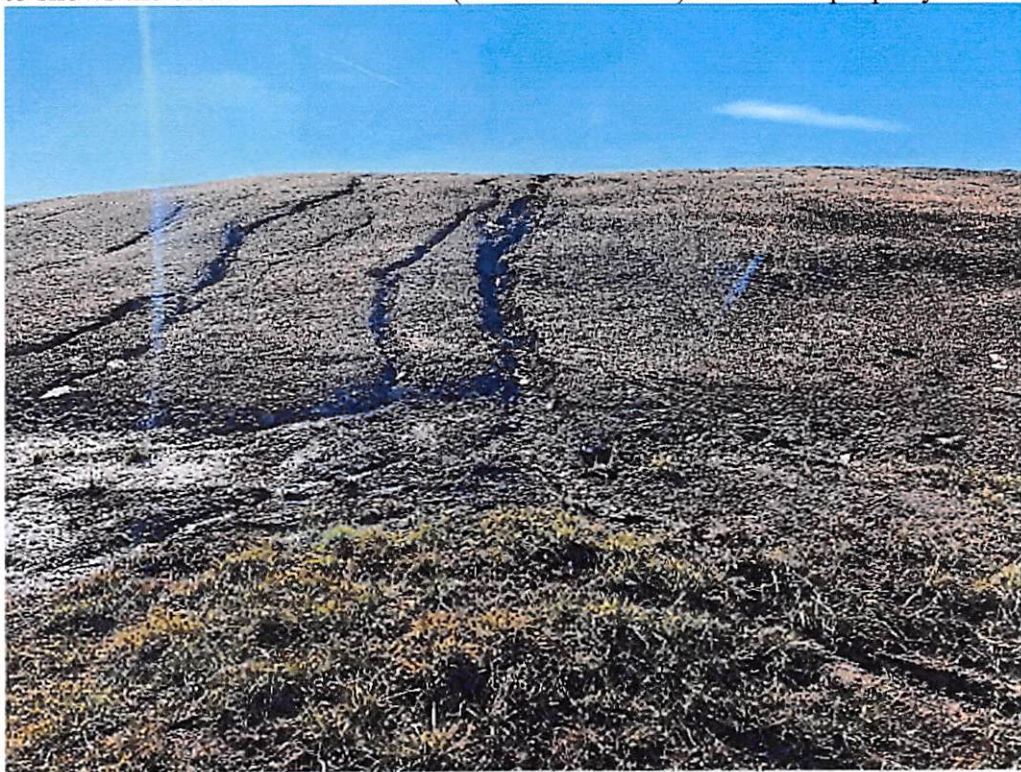
Photo shows several erosion rills on pad 1 created from concentrated flows. These erosion rills lead directly toward a break in the smart fence.

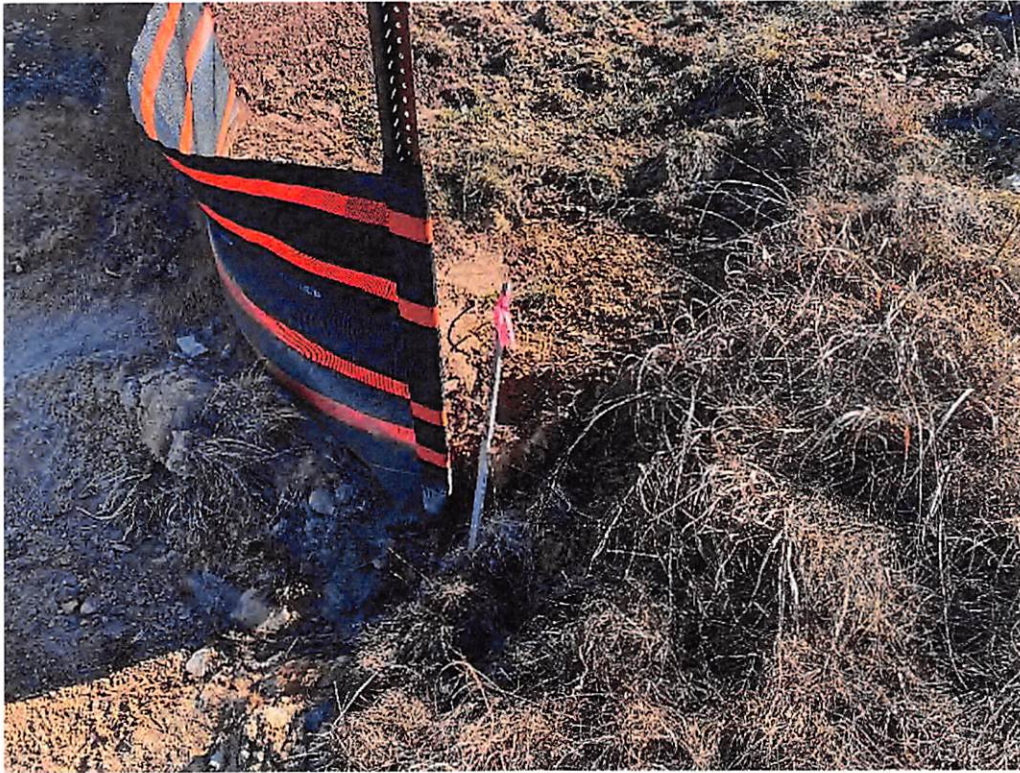
Photo shows where water is running around the smart fence on Pad 1. This is the break in the smart fence down slope the erosion rills in the previous photo.

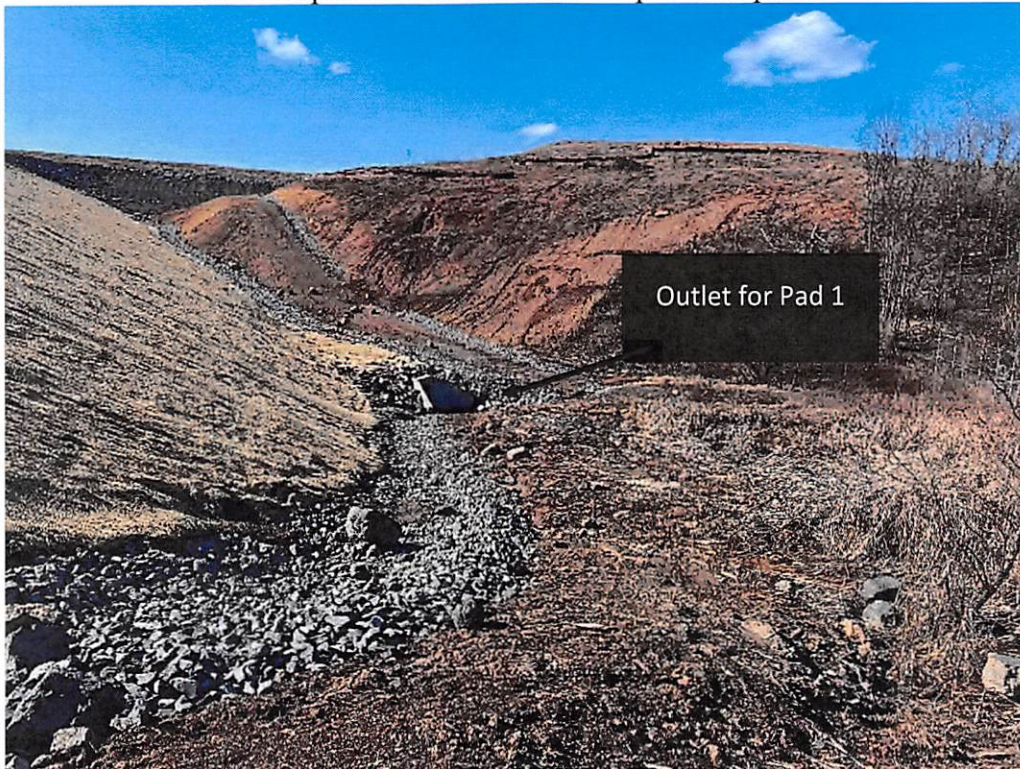
Photo shows an overall view of the outlet for Pad 1. There is no BMP at the outlet for the stormwater that drains from pad 1.

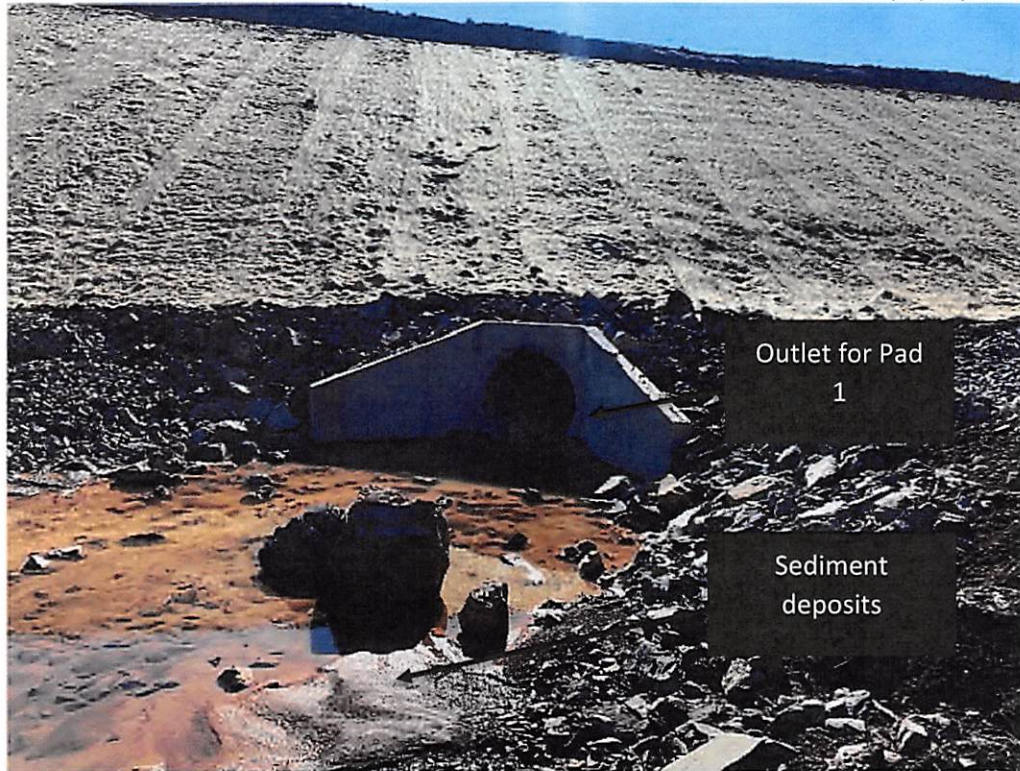
Photo shows the outlet for pad 1 without any BMPs in place.

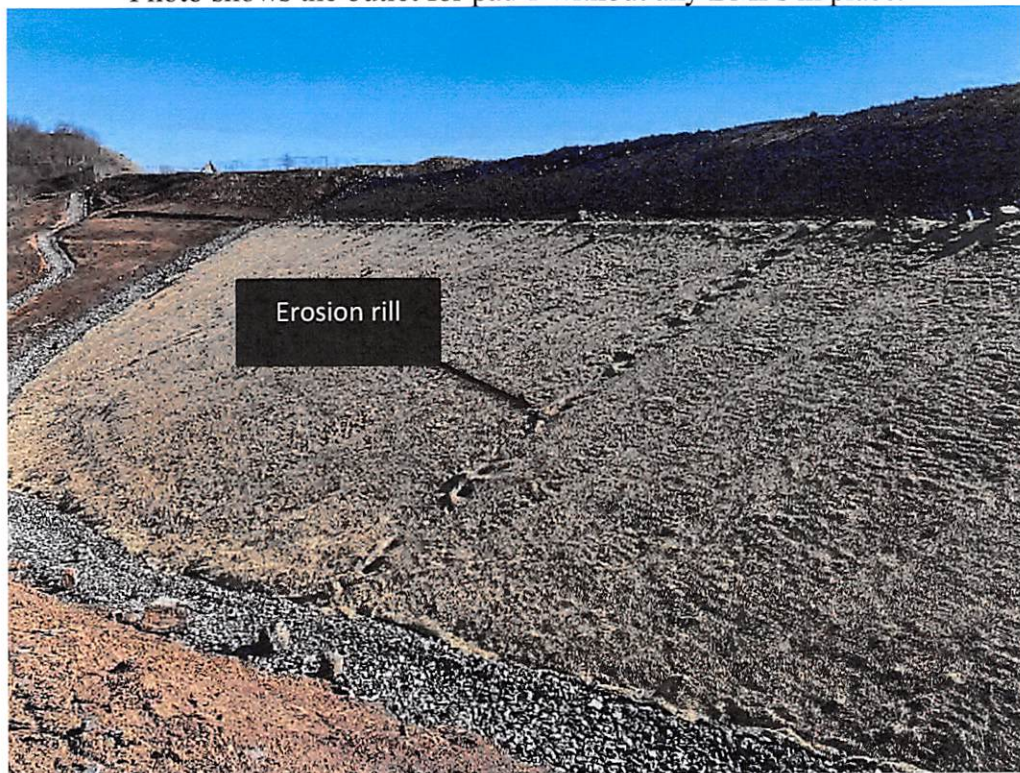
- f. Section II.H.3.b.9.- Benedum Airport Authority failed to protect fill slopes. There were erosion rills forming underneath the straw matting on the slope above the outlet for Pad 1 due to a concentrated flow.

Photo shows an erosion rill forming underneath the straw matting on the hillside above the outlet for Pad 1, which was caused by a concentrated flow on the fill slope.

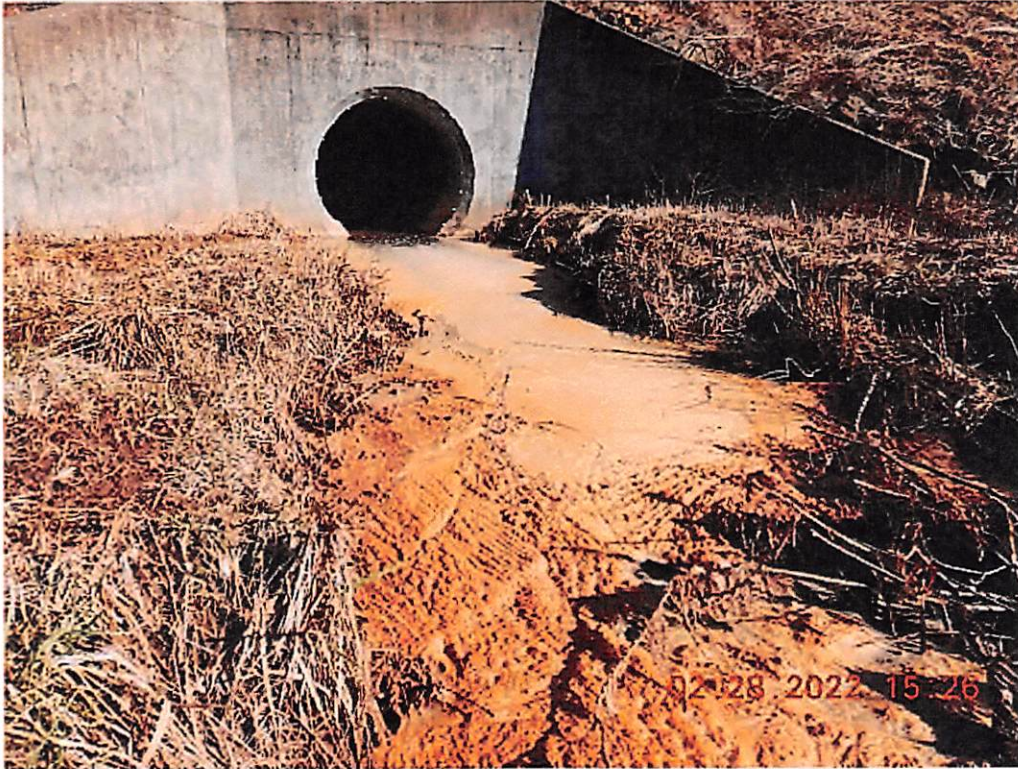
Photo shows the outlet for Pad 1 into a UNT of Ann Run.
